CALSPAN ON-SITE AIR BAG DEPLOYMENT INVESTIGATION

CALSPAN CASE NO. 92-10

VEHICLE - 1991 DODGE CARAVAN

ACCIDENT DATE - [REDACTED] 1992

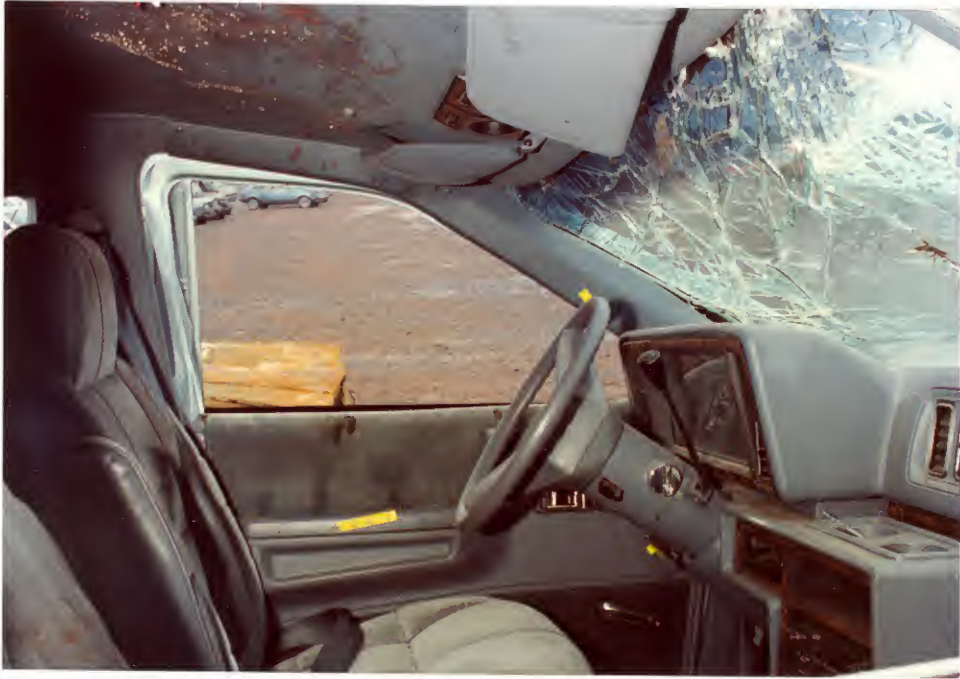
Driver's Seated Area And Contact Points.

There was no residual damage to the vehicle's interior that resulted from occupant contact. The driver probably contacted the left door panel and armrest during the collision sequence. The passenger's left foot exited the right front door opening during the rollover and was subsequently crushed between the right A-pillar and the road surface. White sneaker fragments were embedded between the A-pillar and the door window frame and also between the windshield molding and the A-pillar.

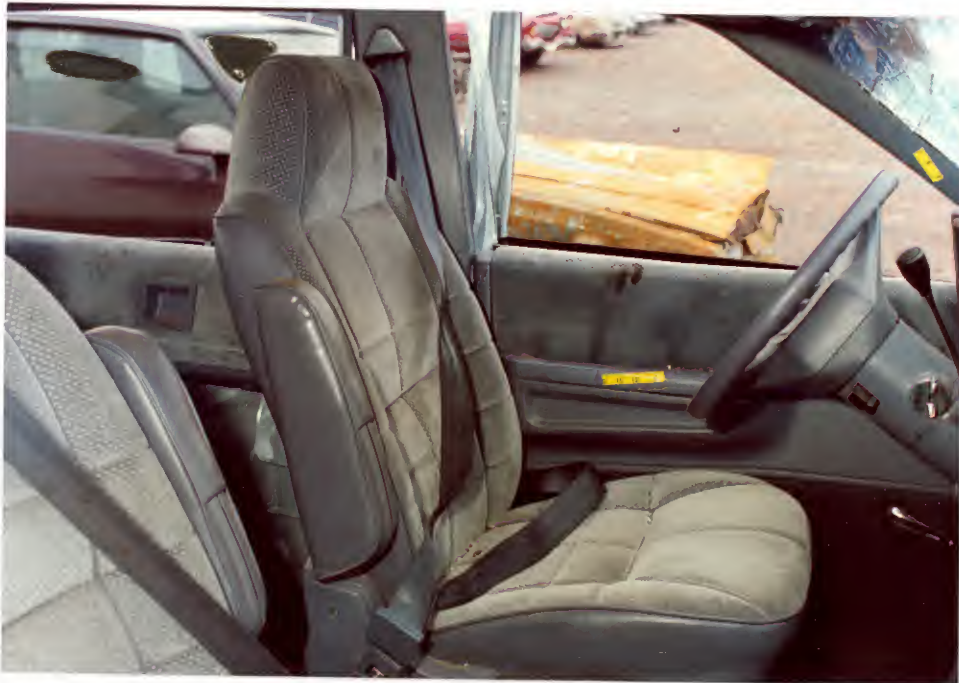
Driver's Seat And Active Restraint System.

The driver of vehicle #2 was in a normal seated position at impact. She was fully restrained by the active 3-point lap and shoulder belt system. Belt usage was supported by driver and police statements, heavy routine wear marks on the latchplate, the post-crash position of the belt webbing (jammed retractor), and the lack of contact points and/or ejection of the driver.

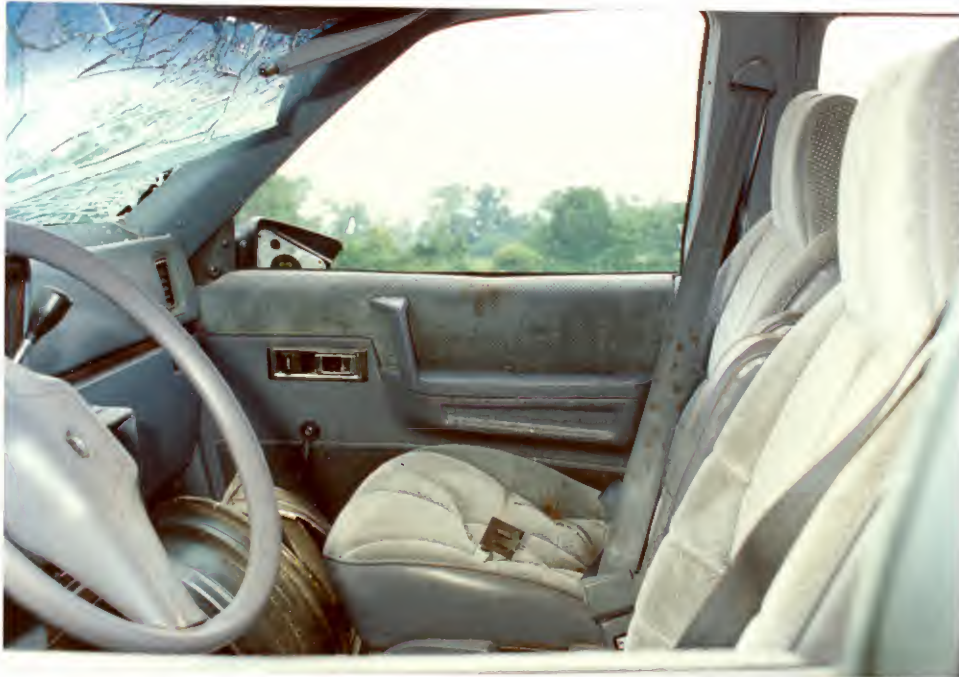
Right Front Occupant's Seat Position And Active Belt System.

The right front passenger of vehicle #2 was in a normal seated position pre-crash as stated by the driver of the vehicle. She was properly restrained by the active 3-point lap and shoulder belt system. Belt usage was confirmed by driver statements, heavy routine wear marks on the latchplate, blood stains on the belt webbings, and the lack of ejection of the right front passenger. There was no loading evidence on the belt system.

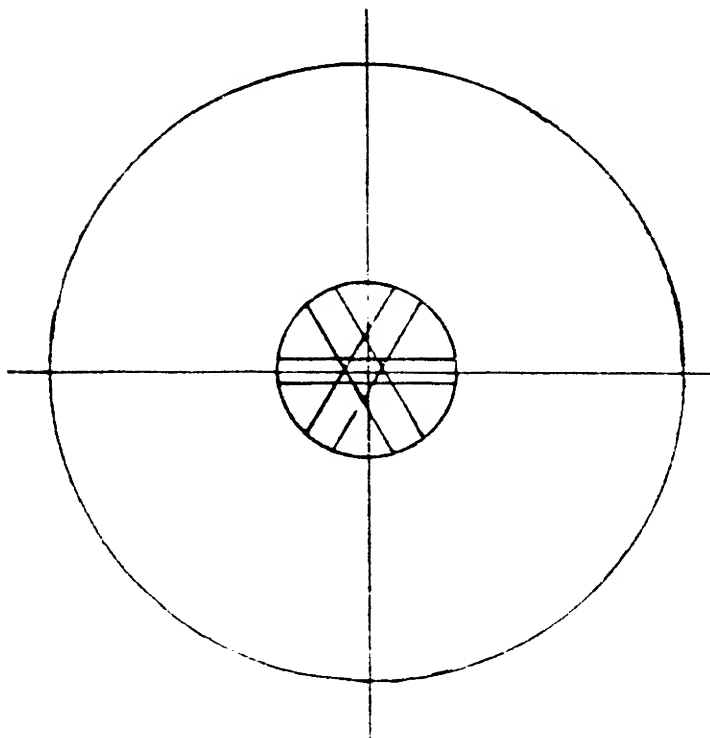
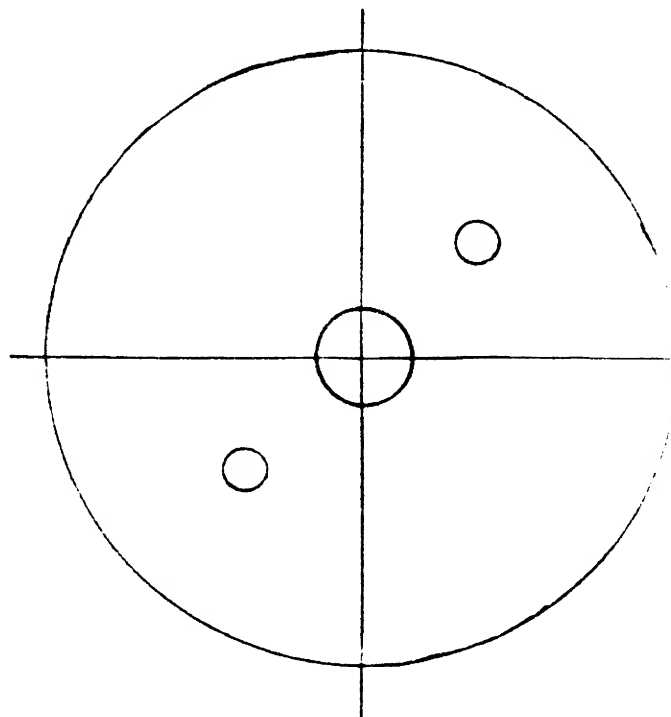
NOTE DAMAGE AND CONTACT MARKS ON AIRBAG DIAGRAMS BELOW:

NO EVIDENCE OF CONTACT

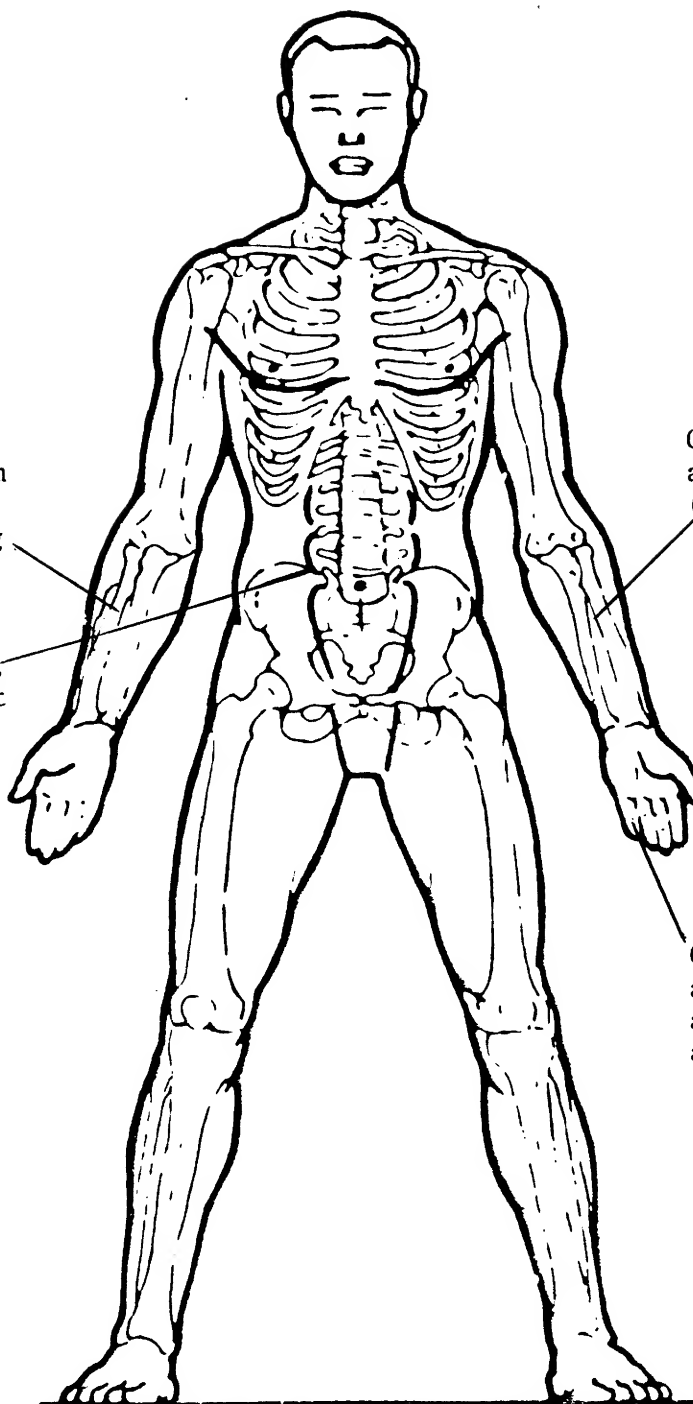
Contusion of the anterior
aspect of the left forearm
(AIS-1), air bag

Contusions of the dorsal
aspect of the left ring
and 5th fingers (AIS-1),
air bag module flap
(Probable)

<u>Injury</u>	<u>Severity (OIC/AIS)</u>	<u>Source</u>
Thermal burn of the right anterior forearm, 7.6cm (3") x 3.8cm (1.5"), hair on forearm was singed	Minor (RRBI-1)	Air bag (Definite)
Contusion of the anterior aspect of the left forearm 17.8cm (7") x 5.1cm (2")	Minor (RLCI-1)	Air bag (Definite)
Contusions of the dorsal aspect of the left ring and 5th fingers	Minor (WLCI-1)	Upper air bag module flap (Probable)
Lumbar strain	Minor (BITM-1)	Impact force/restraint loading
Pain in left shoulder	N/A	Shoulder belt webbing (Definite)
Chest pain	N/A	Shoulder belt webbing (Definite)

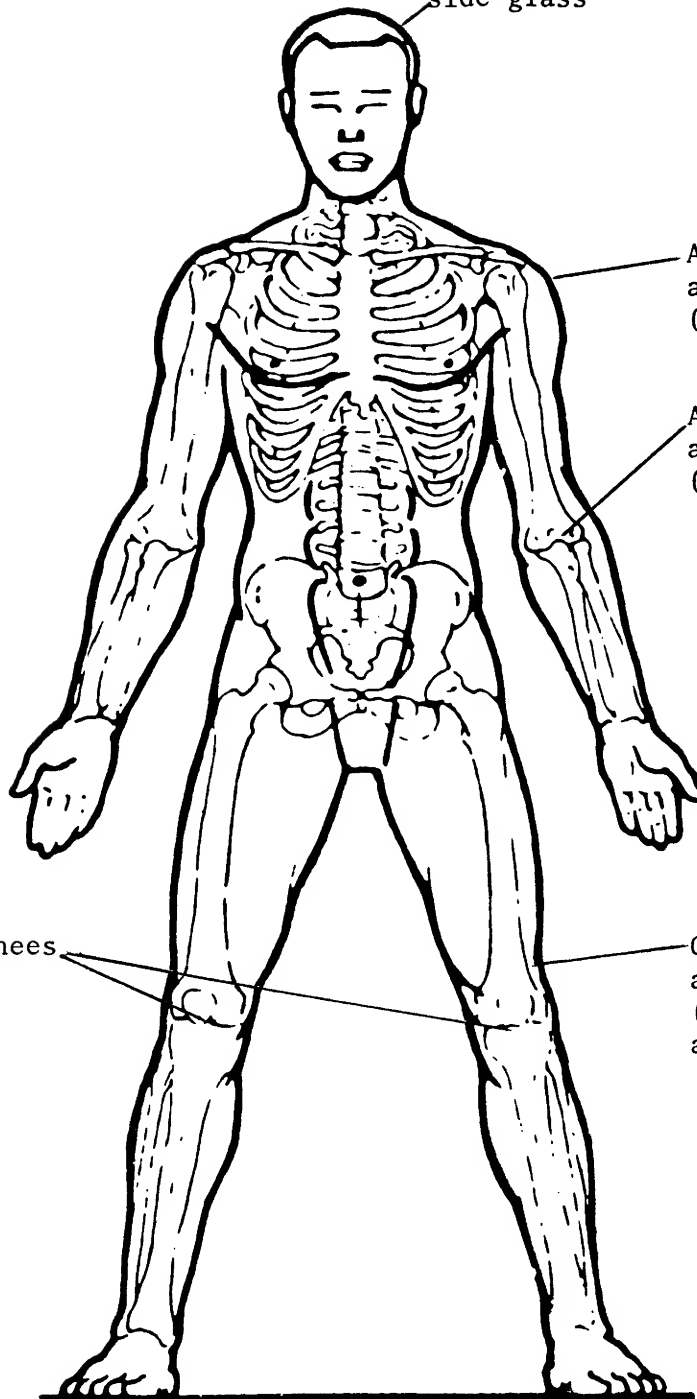
Lacerations of both knees
(AIS-1), contact with
shattered glass

Contusion of the lateral
aspect of the left thigh
(AIS-1), left door panel/
armrest

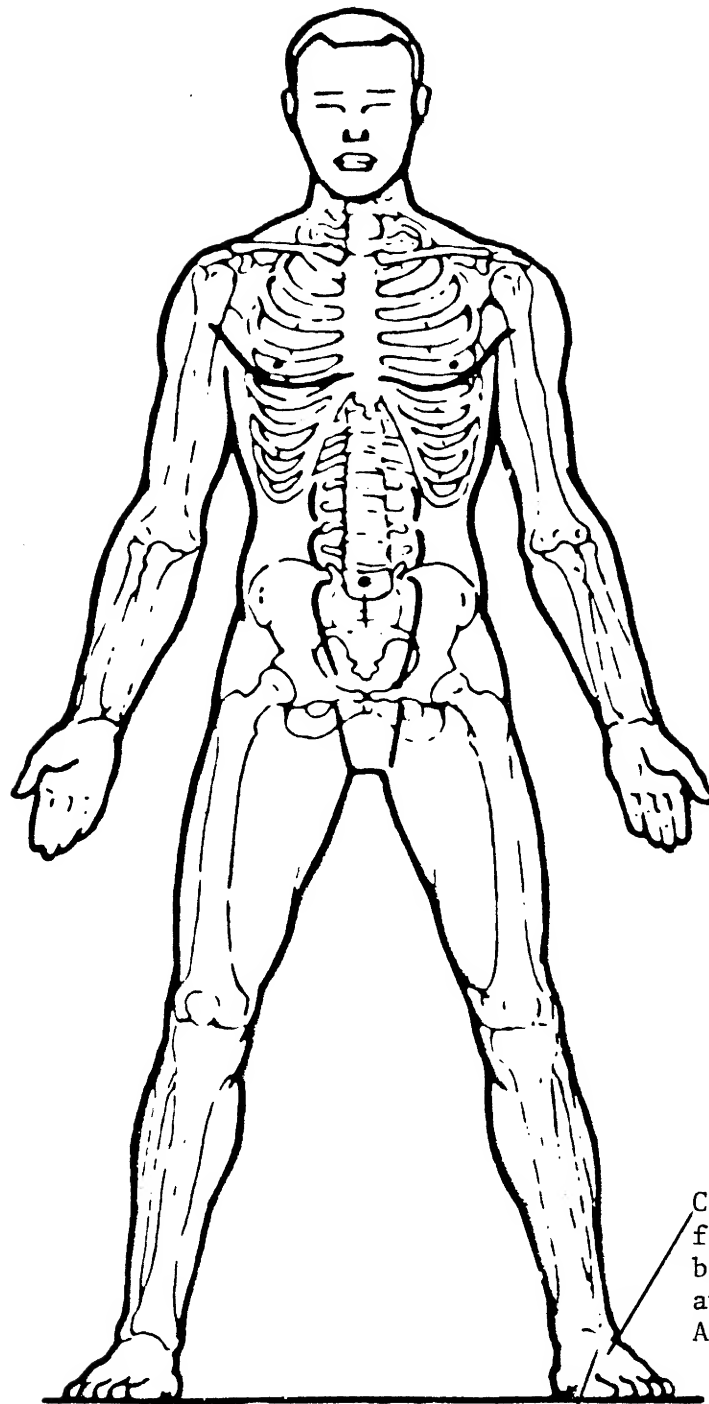
Crushing injury of left foot (AIS-3), crushed between the road surface and the right upper A-pillar

Abrasion to the dorsal aspect of the left foot (AIS-1), road surface/A-pillar
